Manhole Inspection Summary

Manhole # S25KK1024MH

Location Address: **4404 EVANS CHAPEL RD** Cross Street: **COLD SPRING LN**

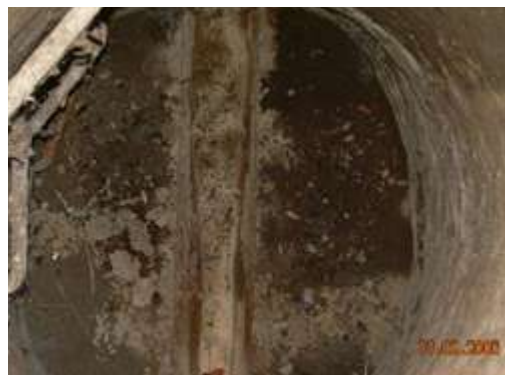
Top View

Bench ☒ Exists Material: **Brick** ☐ Parged ☒ **Debris** (not Condition related)
Condition: ☒ Sound ☐ Cracked ☐ Root Intrusion ☐ Deteriorated ☐ Leaks ☐ Debris

Corroded steps. Bench debris.

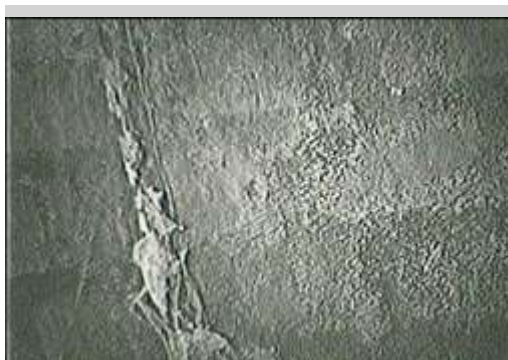
Defect

Chimney / Frame Adjustment ☒ Exists Material: **Brick** ☐ Parged Height: **15** (in.)
Condition: ☐ Sound ☐ Cracked ☐ Root Intrusion ☐ Loose Brick ☒ **Deteriorated**
Infiltration: ☐ None ☒ **Joint** ☐ Cracks ☐ Mortar ☐ Roots ☒ **Wall**

Corbel Material: **Brick** ☐ Parged Type: **Concentric/Eccentric**
Condition: ☐ Sound ☐ Cracked ☐ Root Intrusion ☐ Loose Brick ☒ **Deteriorated**
Infiltration: ☐ None ☐ Joint ☐ Cracks ☐ Mortar ☐ Roots ☒ **Wall**

Adjustment and Corbel deterioration and infiltration.

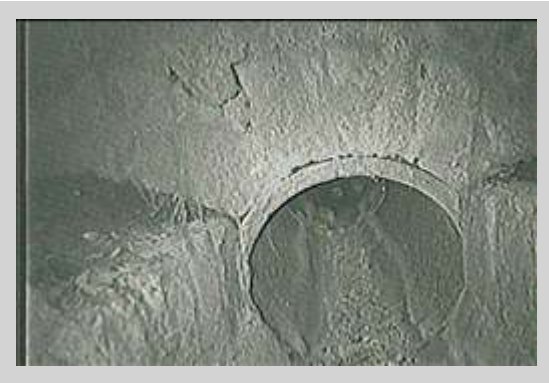
8 in. Circular Gravity Sewer Pipe Out @ 12 O'Clock

Barrel Material: **Brick** ☐ Parged
Shape: **Circular** Diameter: **42** (in.) Length: (in.)
Condition: ☐ Sound ☒ **Cracked** ☐ Root Intrusion ☐ Loose Brick ☐ Deteriorated
Infiltration: ☐ None ☐ Joint ☒ **Cracks** ☐ Mortar ☐ Roots ☐ Wall

Barrel cracks.

Deposits: ☐ None ☒ **Mud** ☐ Sludge ☒ **Debris** ☐ Grease

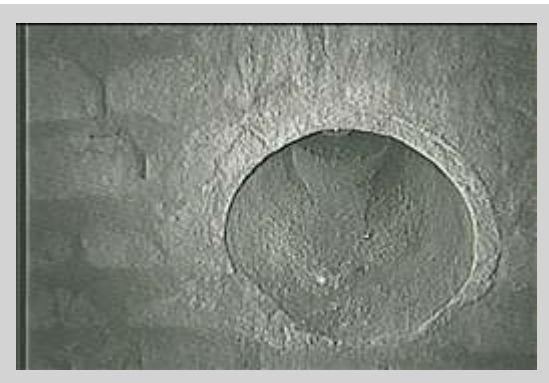
8 in. Circular Gravity Sewer Pipe In @ 6 O'Clock

Deposits: ☐ None ☐ Mud ☐ Sludge ☒ **Debris** ☐ Grease

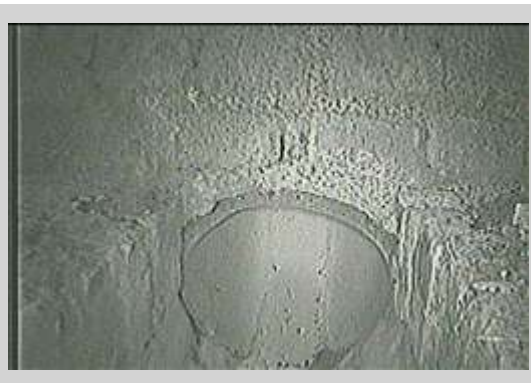
Drop In @ 6 O'Clock

Drop: **Outside** Rod and Bar

Drop Condition: **Open**
